(NASA-CR-183585) SPACE STATION PROTECTIVE
COATING DEVELOPMENT Final Report (Boeing
Aerospace Co.) 304 p CSCL 22B

SPACE STATION PROTECTIVE COATING DEVELOPMENT

Final Report

**Contract NAS8-36586
January 1989**

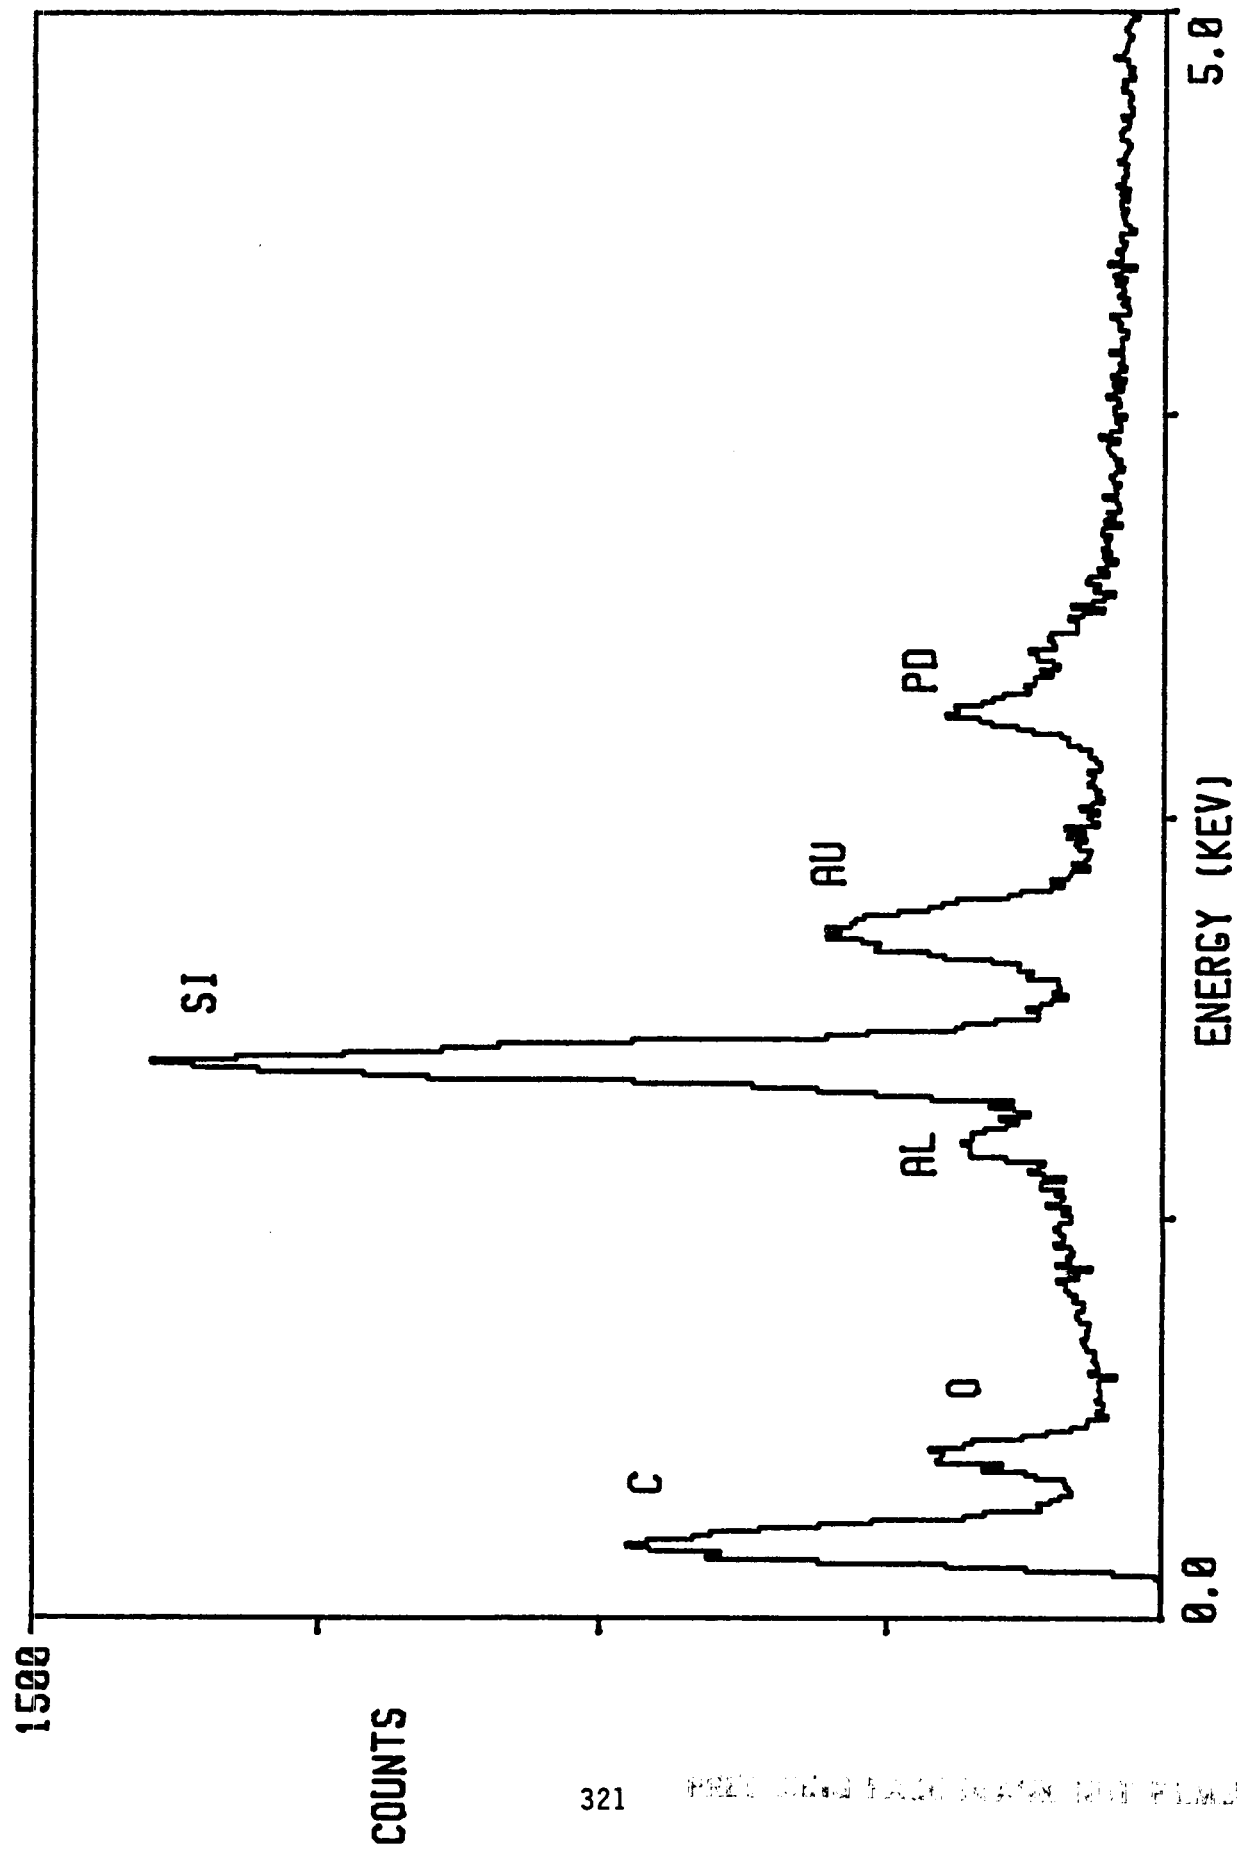
MTL-50. PREX.

Figure 112: EDAX Spectrum of HMDS Coating (#50) on Kapton

Title: Mtl-50. BREL. R = 15. Photo #013. Magnification: 50X. Legend: Bend Region of Battelle HMDS After BREL Solar UV/Thermal Vacuum Cycling, Over a 15 mil Bend Diameter (Material #50). Description: Typical view of bend region of this sample. The solitary crack seen in photo #012 cannot be seen easily in this picture. EDAX analysis indicates a possible slight increase in Si and O levels in the BREL-tested material when compared to the as-received virgin material. These EDAX spectra are shown in figures 112 and 113

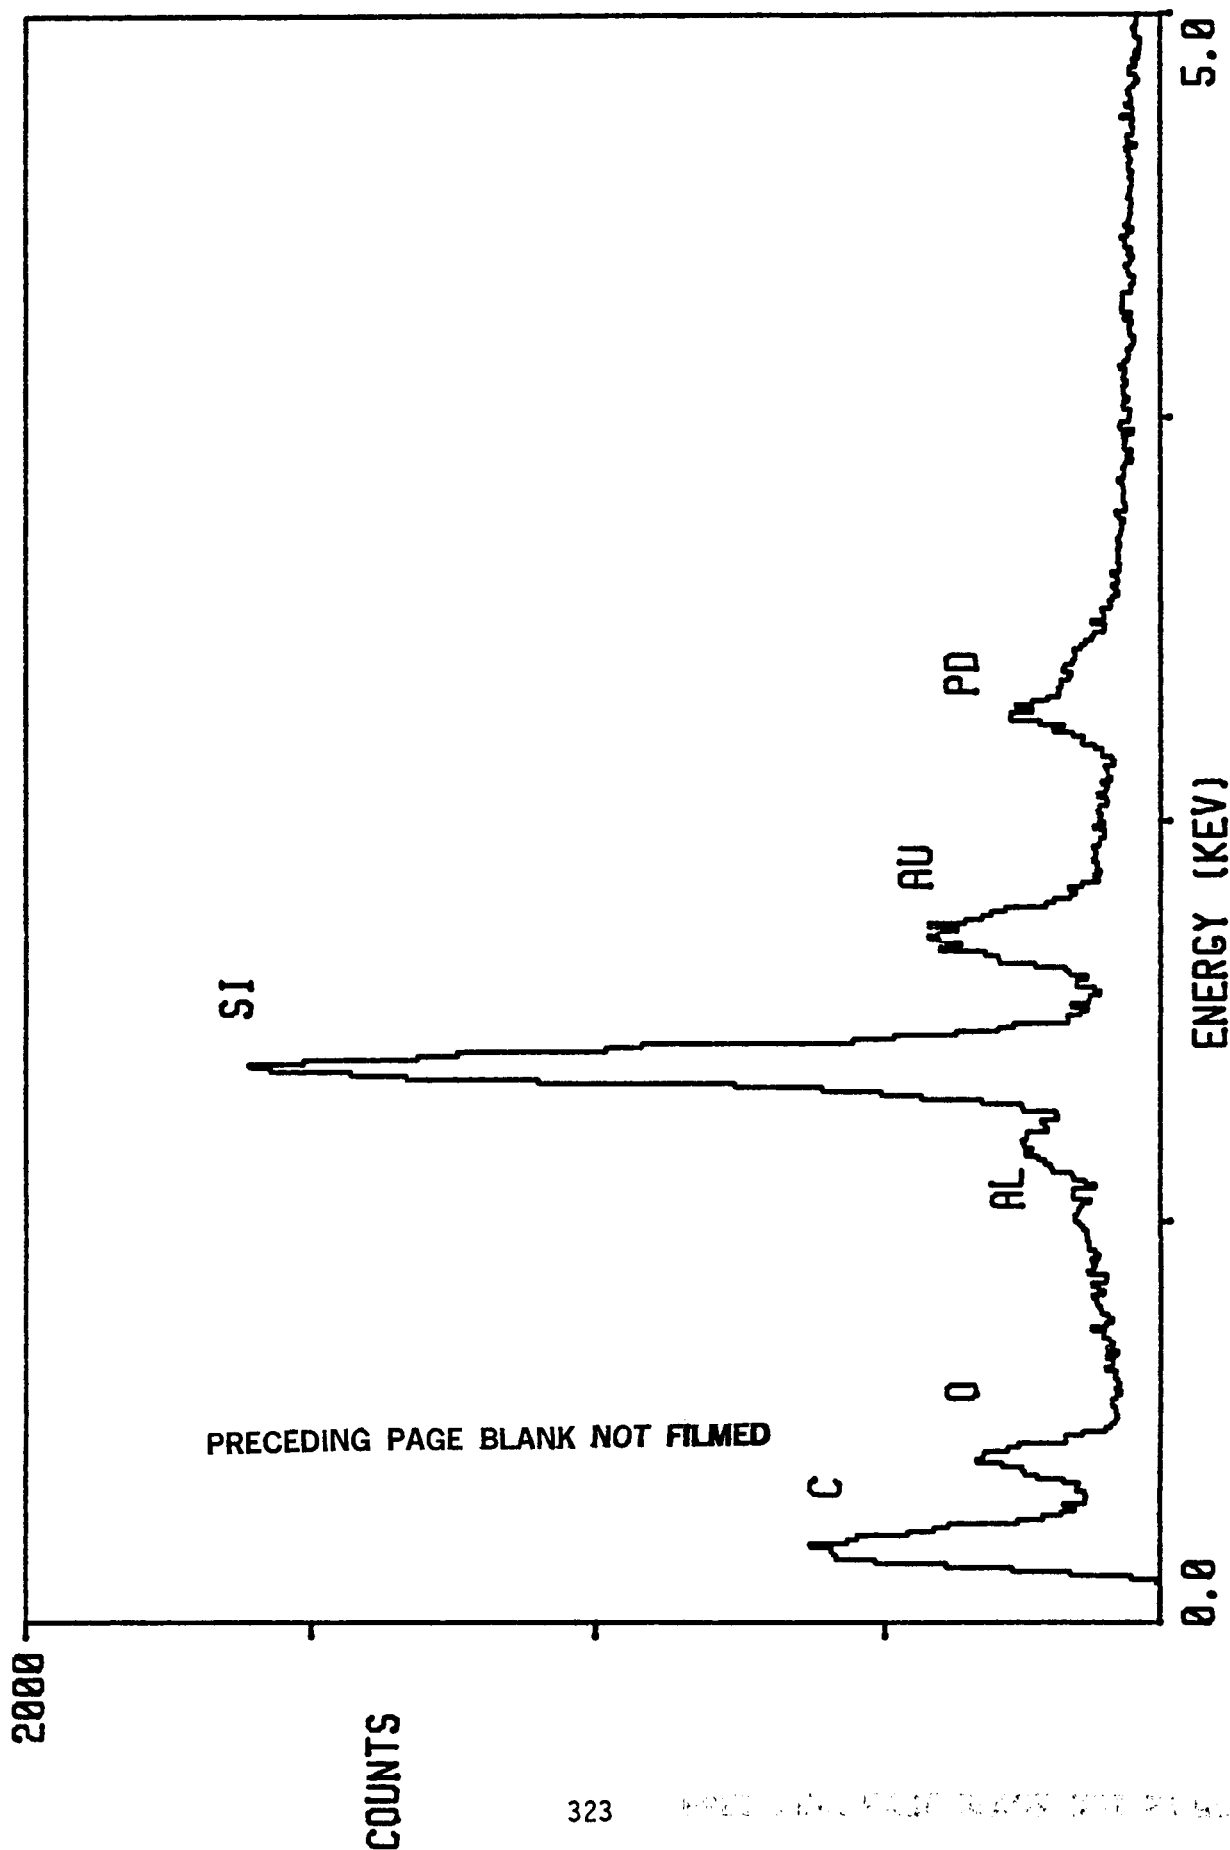
MTL-50. BREL.

Figure 113: EDAX Spectrum of HMDS Coating on Kapton. Specimen Previously Exposed to Combined Vacuum Thermal Cycling/UV Radiation

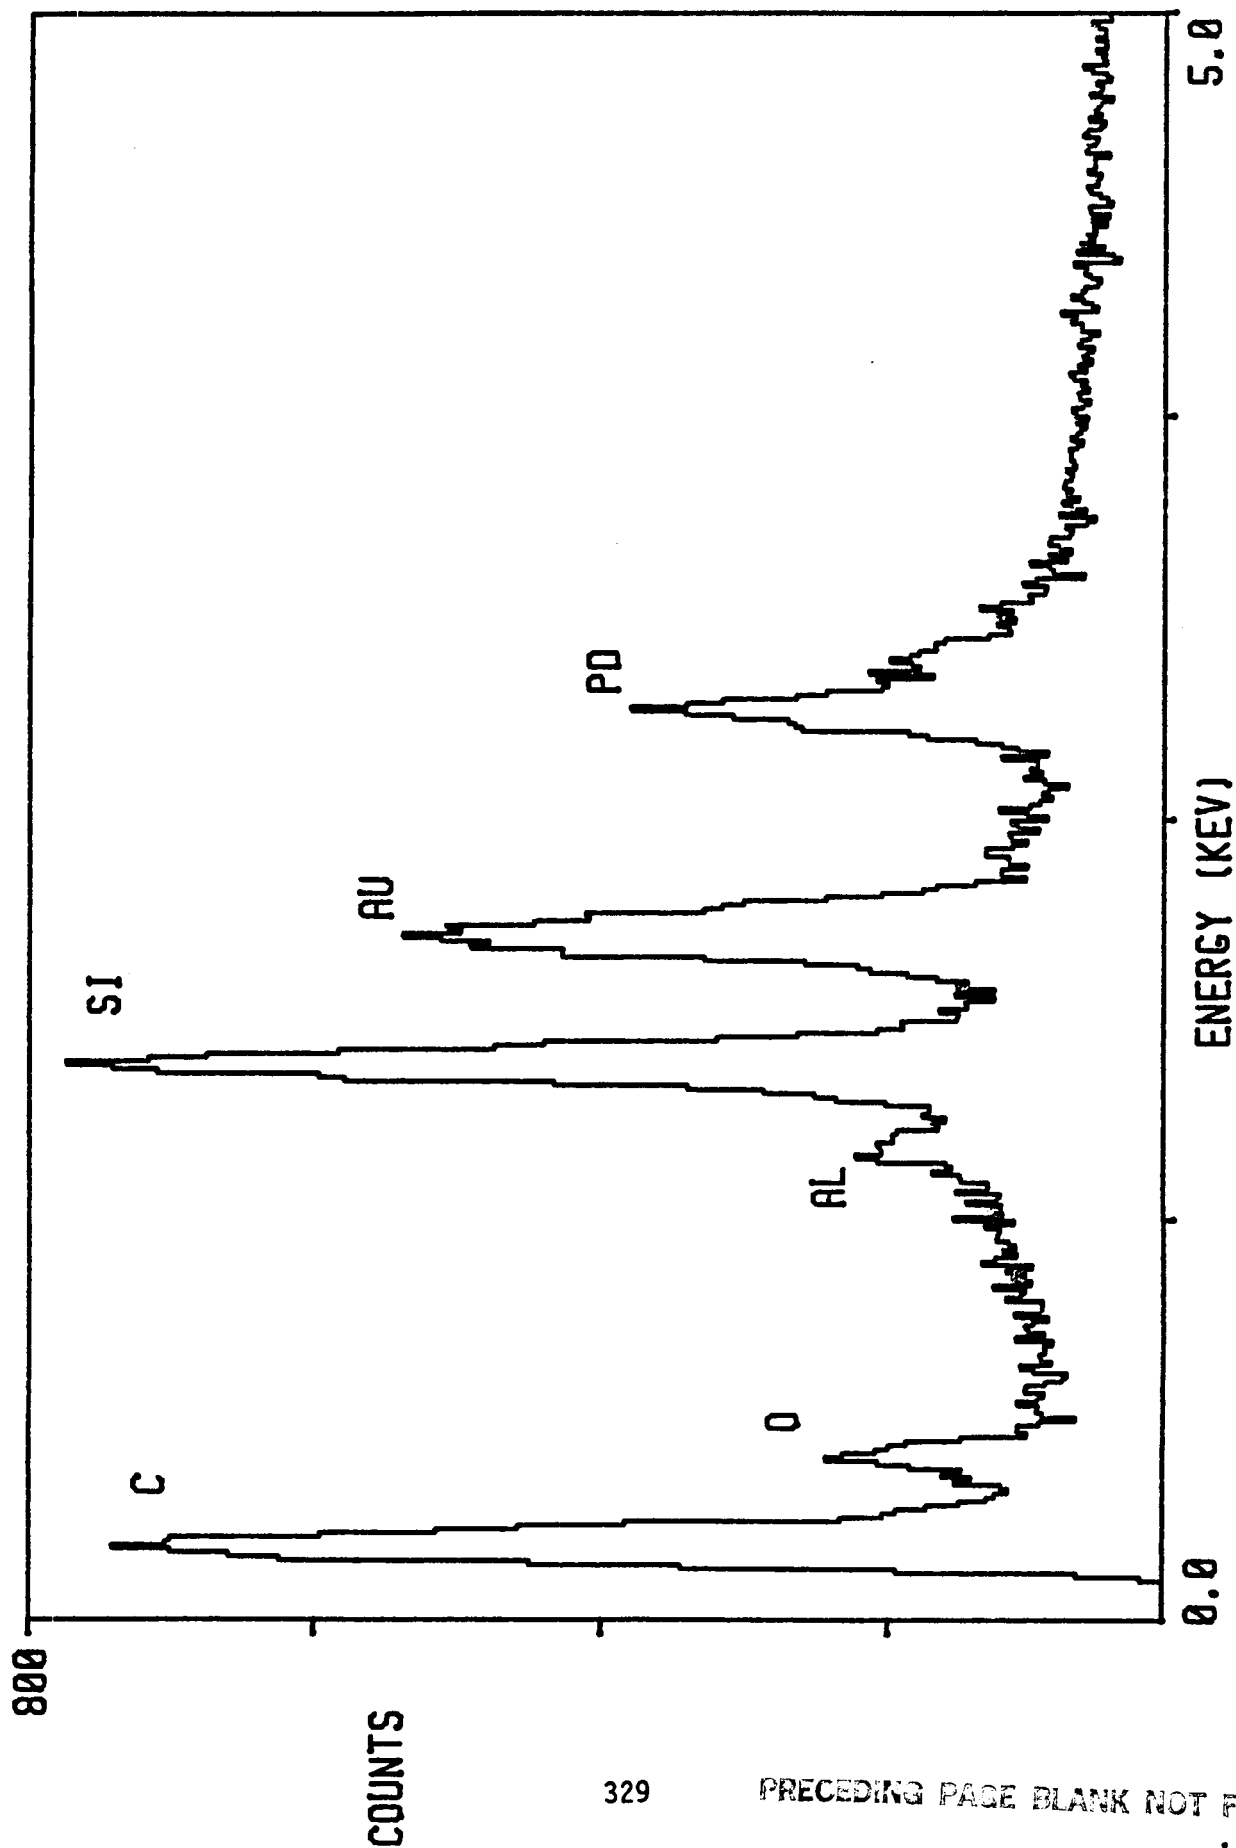
MTL-52. PREX.

Figure 118: EDAX Spectrum of HMDS/TFE Coating on Kapton

Title: Mtl-52. BREL. R = 15. Photo #015. Magnification: 50X. Legend: Bend Region of Battelle Plasma Polymerized HMDS/TFE (Ratio 8/1) Coating, After Solar UV/Thermal Vacuum Cycling, Over a 15 mil Bend Diameter (Material #52). Description: No cracks were observed in the surface of this material, even at much higher magnification levels. The horizontal line seen at the top of this photo is the actual edge of the curved surface, similar to that seen at the bottom. EDAX analysis indicates a slight decrease in C and a slight increase in Si upon BREL testing. This may reflect some silicone to silica conversion in the coating's surface. These EDAX spectra are shown in figures 118 and 119.

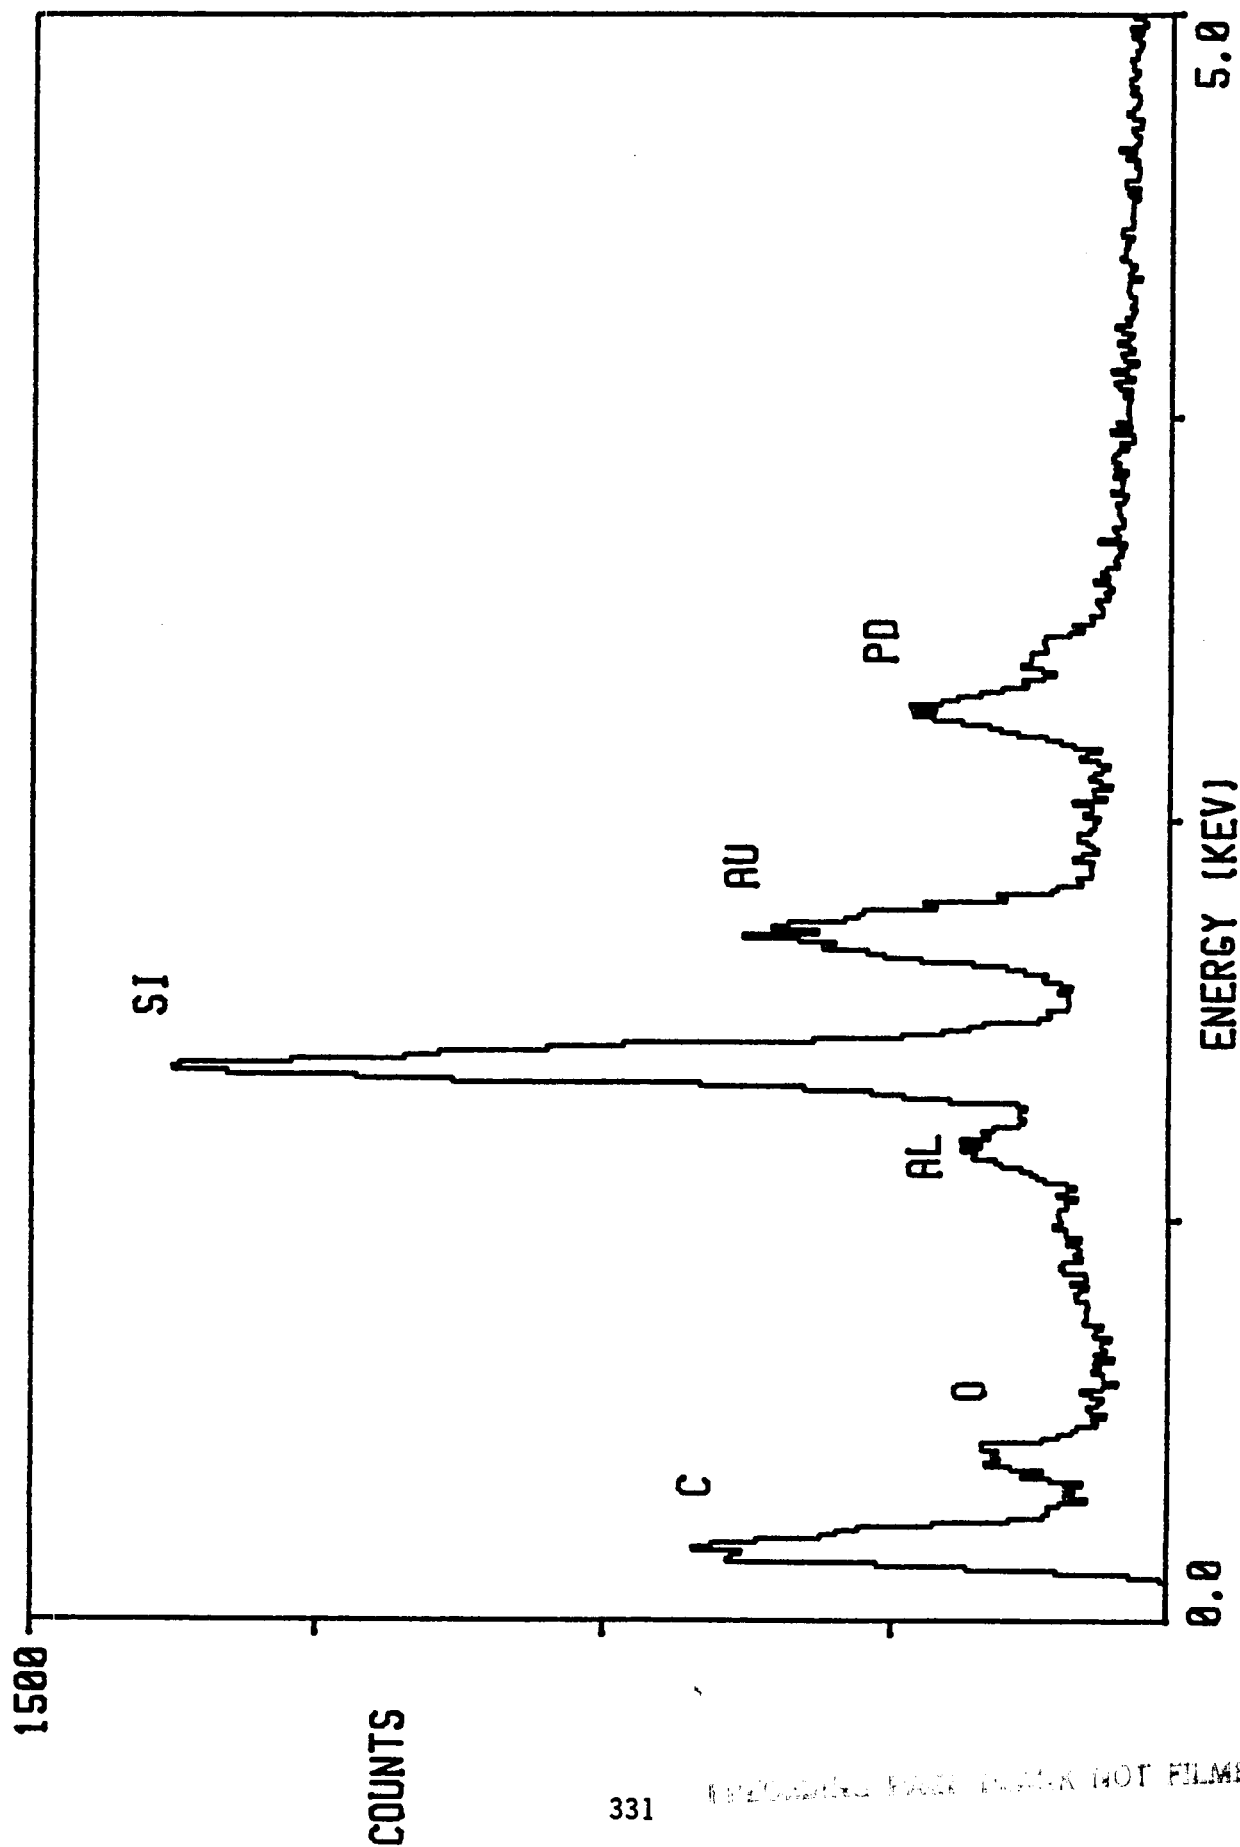
MTL-52. BREL.

Figure 119: EDAX Spectrum of HMDS/TFE Coating on Kapton. Sample Previously Exposed to Combined Vacuum Thermal Cycling/UV Radiation

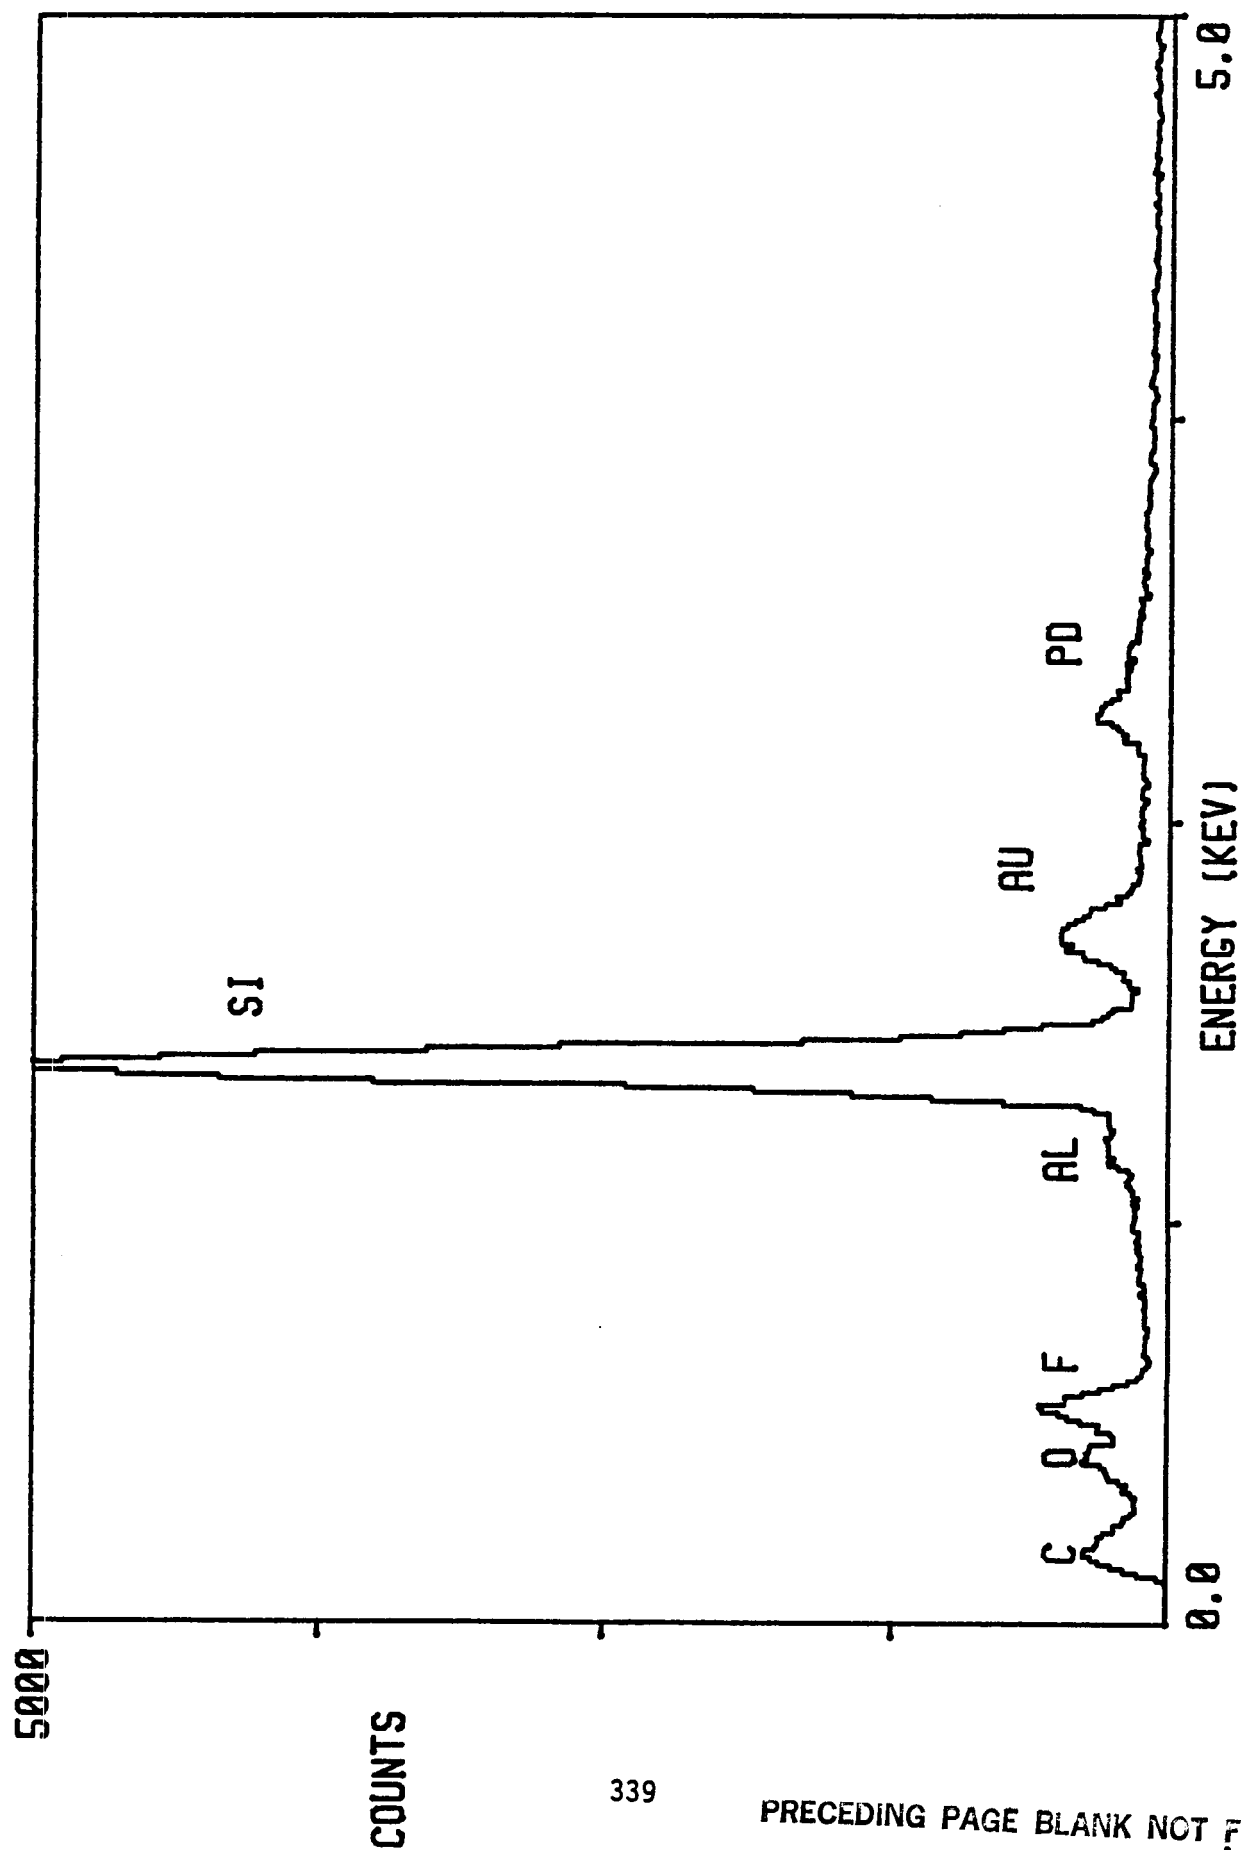
MTL-66. PREX.

Figure 124: EDAX Spectrum of CV1-3530 Fluorosilicone Coating (#66) on Kapton

Title: Mtl-66. BREL. R = 15. Photo #020. Magnification: 50X. Legend: Single Crack in Surface of McGhan-NuSil CV1-3530 Fluorosilicone Coating, After solar UV/Thermal Vacuum Cycling, Over a 15 mil Bend Diameter (Material #66). Legend: A single solitary crack was observed in the bend region of this sample. No other cracks were seen. EDAX analysis indicates a slight decrease in O and F, but not C, levels in the BREL tested material. These results are shown in figures 124 and 125.

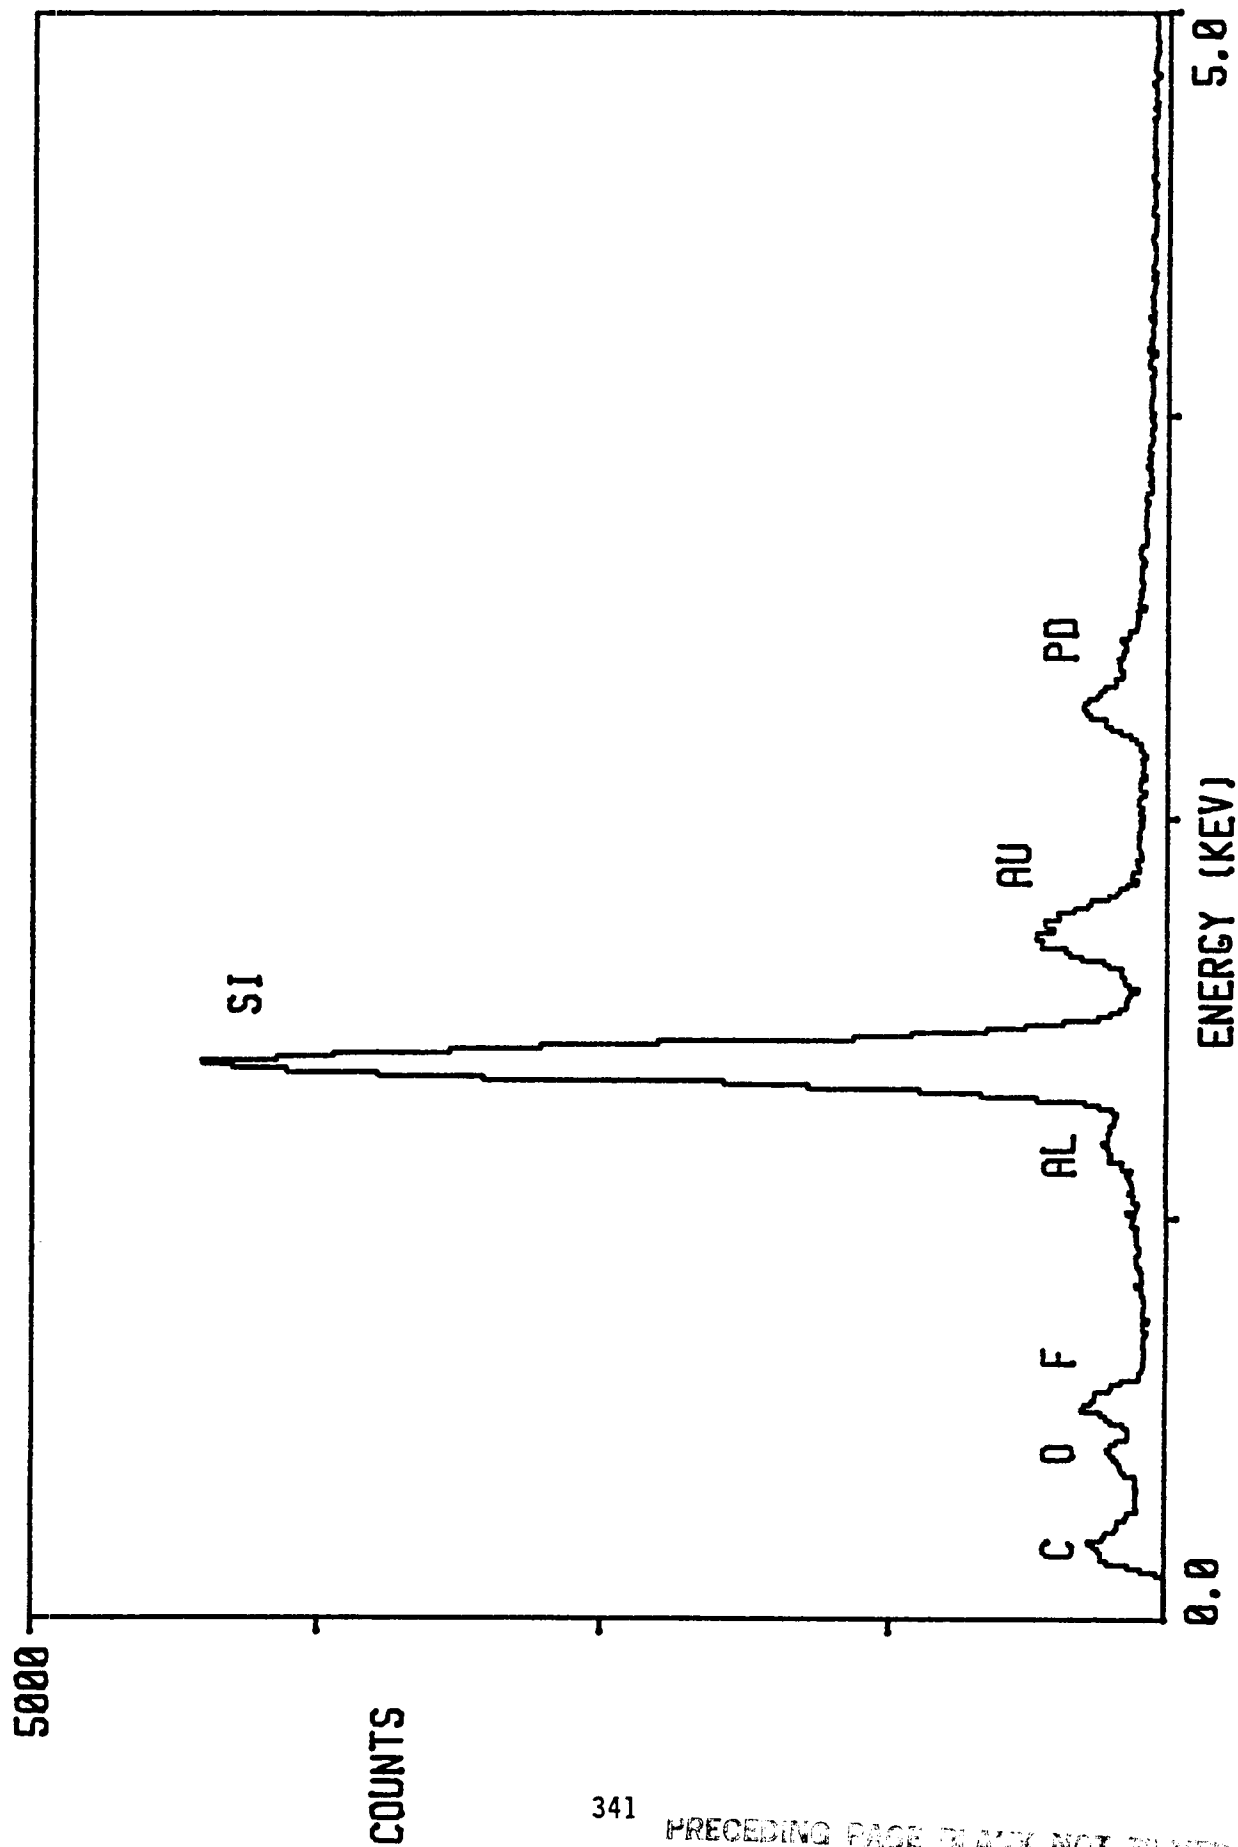
MTL-66. BREL.

Figure 125: EDAX Spectrum of CVI-3530 Coating on Kapton. Sample Previously Exposed to Combined Vacuum Thermal Cycling/UV Radiation

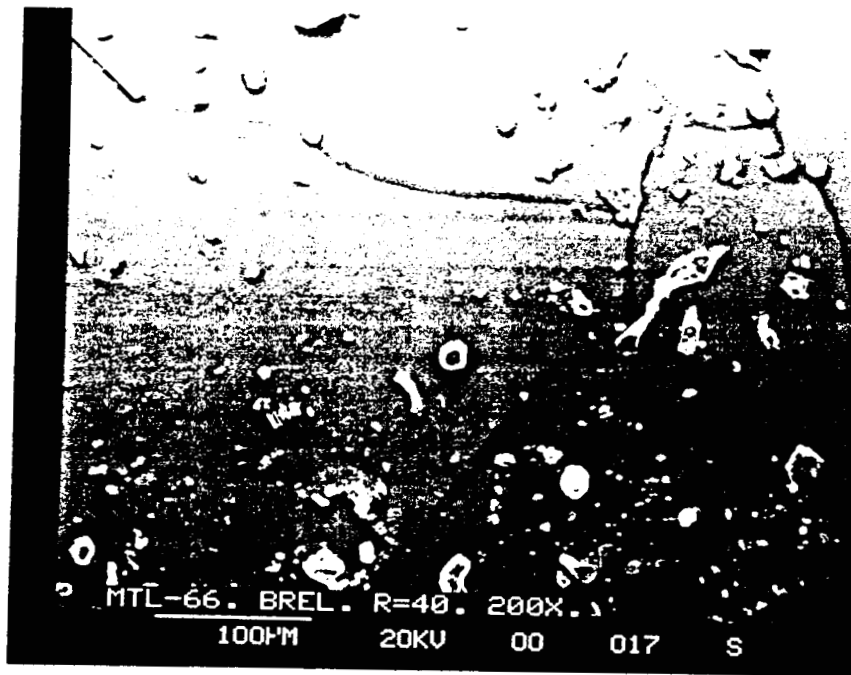
Title: Mtl-66. BREL. R = 40. Photo #017. Magnification: 200X. Legend: Cracks in Surface of McGhan-NuSil CV1-3530 Fluorosilicone Coating, After Solar UV/Thermal Vacuum Cycling, Over a 40 mil Bend Diameter (Material #66). Description: Many such cracks were in the coating as seen in this picture. The fact that similar cracking was not seen for the smaller bend diameter test of this material is not understood. The cracks observed in this sample may be an artifact due to handling.

Figure 126: CVI-3530 Fluorosilicone Coating on Kapton Bent Over a 40-Mil Radius. Sample Previously Exposed to Combined Vacuum Thermal Cycling/UV Radiation.

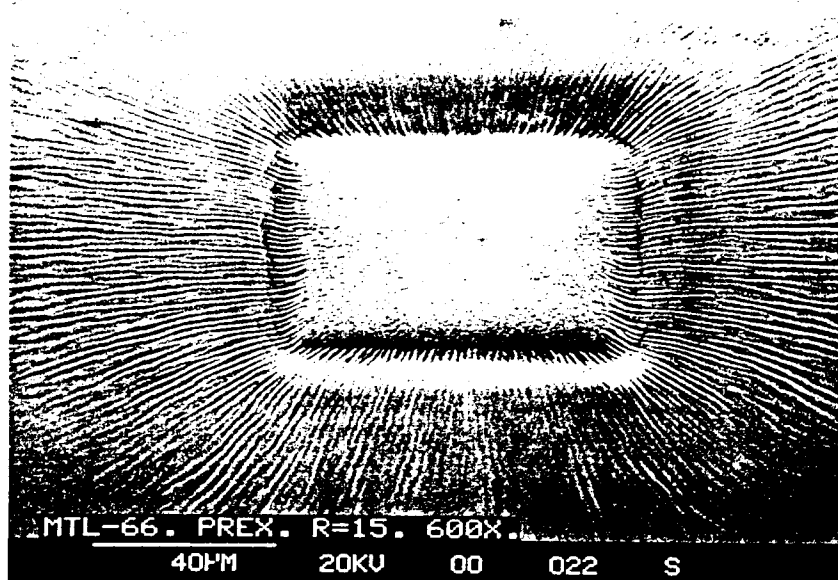
Title: Mtl-66. PREX. R = 15. Photo #022. Magnification: 600X. Legend: SEM Electron Beam Damage to McGhan-NuSil CV1-3530 Fluorosilicone Coating, Over a 15 mil Bend Diameter (Material #66).

Figure 128: SEM Beam Damage to Previously Identified Region of CVI-3530 Fluorosilicone Coating (#66) on Kapton Bent Over 15-Mil Radius

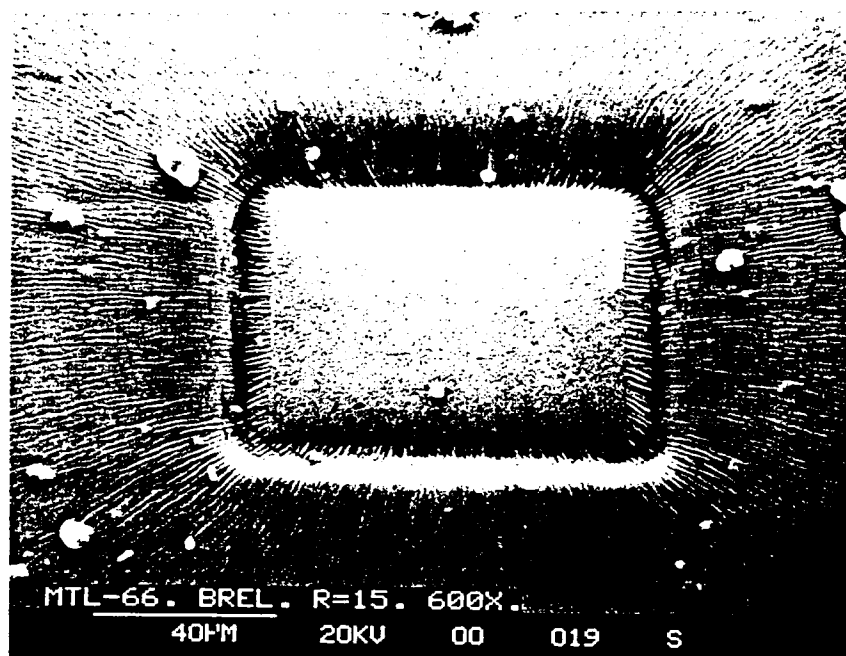
Title: Mtl-66. PREX. R = 15. Photo #021. Magnification: 50X. Legend: Cracks in Surface of As-Received McGhan-NuSIL CV1-3530 Fluorosilicone Coating, Over a 15 mil Bend Diameter (Material #66). Description: A view of two large, typical cracks seen in the surface of this coating. Note the auto-tracking contrast function was not used in this photo, resulting in wide contrast differences in the resulting picture.

Figure 129: SEM Beam Damage to Previously Identified Region of CVI-3530 Fluorosilicone Coating (#66) on Kapton Bent Over 15-Mil Radius. Sample Previously Exposed to Combined Vacuum Thermal Cycling/UV Radiation
